THE SPACE SHUTTLE CHALLENGER ACCIDENT

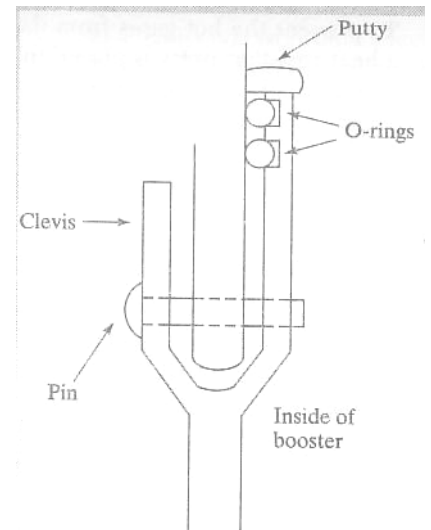
A key aspect of the booster design are the joints where the individual cylinders come together, known as the field joints, illustrated schematically in Figure 1.a. These are tang and clevis joints, fastened with 177 clevis pins. The joints are sealed by two O-rings, a primary and a secondary. The O-rings are designed to prevent hot gases from the combustion of the solid propellant from escaping. The O-rings are made from a type of synthetic rubber and so are not particularly heat resistant.

To prevent the hot gases from damaging the O-rings, a heat-resistant putty is placed in the joint. The Titan booster had only one O-ring in the field joint. The second O-ring was added to the booster for the shuttle to provide an extra margin of safety since, unlike the Titan, this booster would be used for a manned space craft.

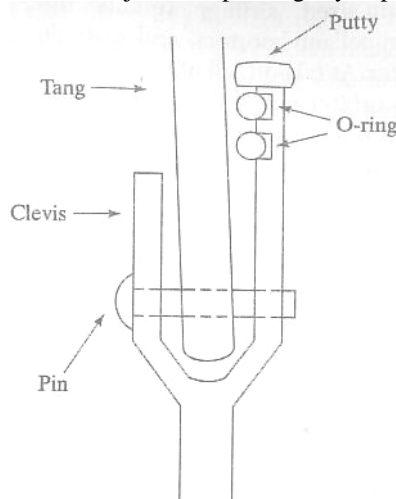
Problems with the field-joint design had been recognized long before the launch of the Challenger. When the rocket is ignited, the internal pressure causes the booster wall to expand outward, putting pressure on the field joint. This pressure causes the joint to open slightly; a process called "joint rotation," illustrated in Figure 1.b. The joint was designed so that the internal pressure pushes on the putty, displacing the primary O-ring into this gap, helping to seal it. During testing of the boosters in 1977, Thiokol became aware that this joint-rotation problem was more severe than on the Titan and discussed it with NASA. Design changes were made, including an increase in the thickness of the O-ring, to try to control this problem.
